BENTON COUNTY
Utility Assessment
November 2021

Utility Assessment

Benton County, Oregon

November 2021

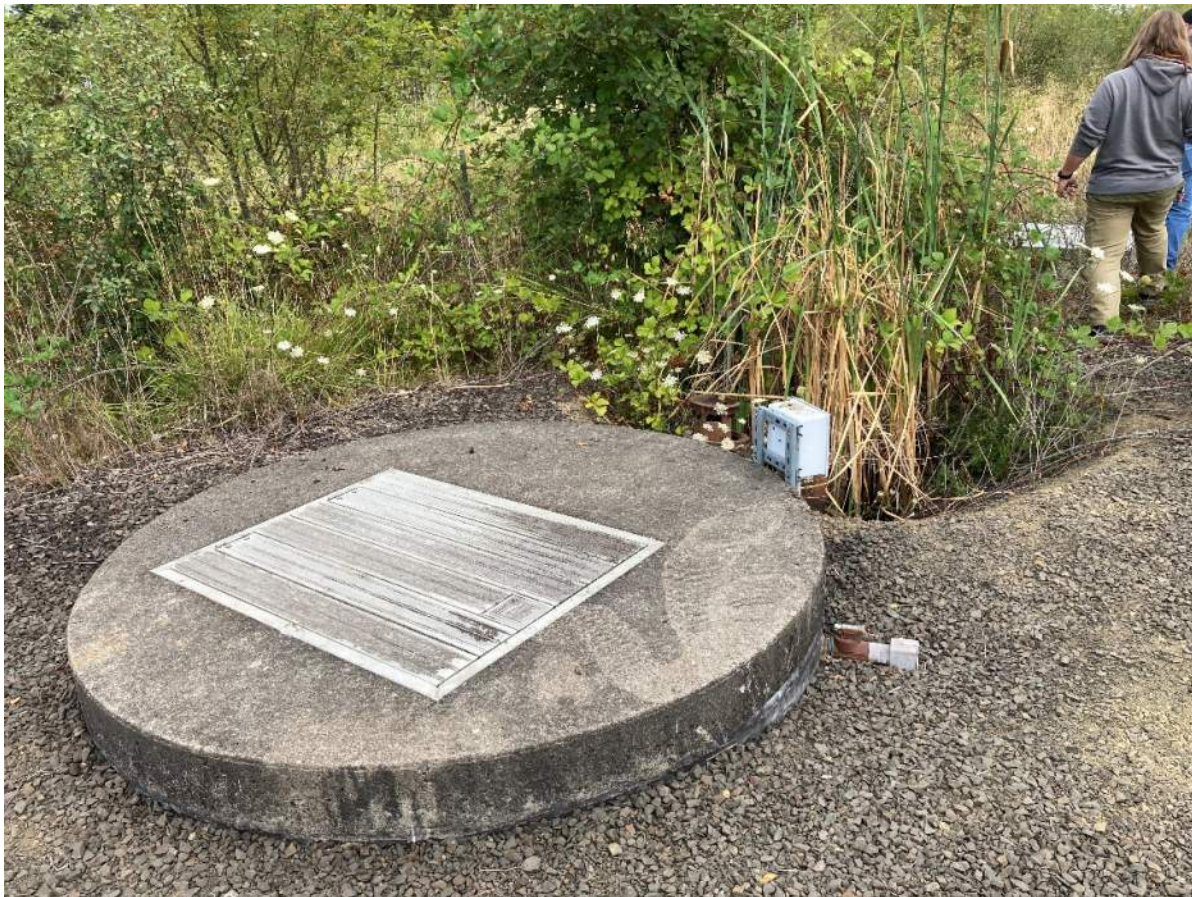
Figure 2-2 Influent Pump Station (In Foreground) and Meter Vault

Observations: Corrosion of the piping within the wet well was observed. Check valves on the pump discharge piping are located in the wet well, partially submerged in the wastewater, isolation valves are in valve boxes adjacent to the wet well. Debris was observed in the wet well, the type or accumulation of debris did not seem unusual for a wastewater pump station.

Both the pump station and meter vault are in a low-lying area prone to flooding at the plant site and vegetation surrounds the meter vault. At the time of the visit, the meter vault was not accessible.

- Replace discharge piping and locate check and isolation valves in separate vault.
- Provide gravel surfacing to control vegetative growth, grade to drain site as much as practical.
- Provide a standby generator at the influent pump station.

- Clear the area around the influent pump station and meter vaults.
- Access the meter vault and inspect its condition.

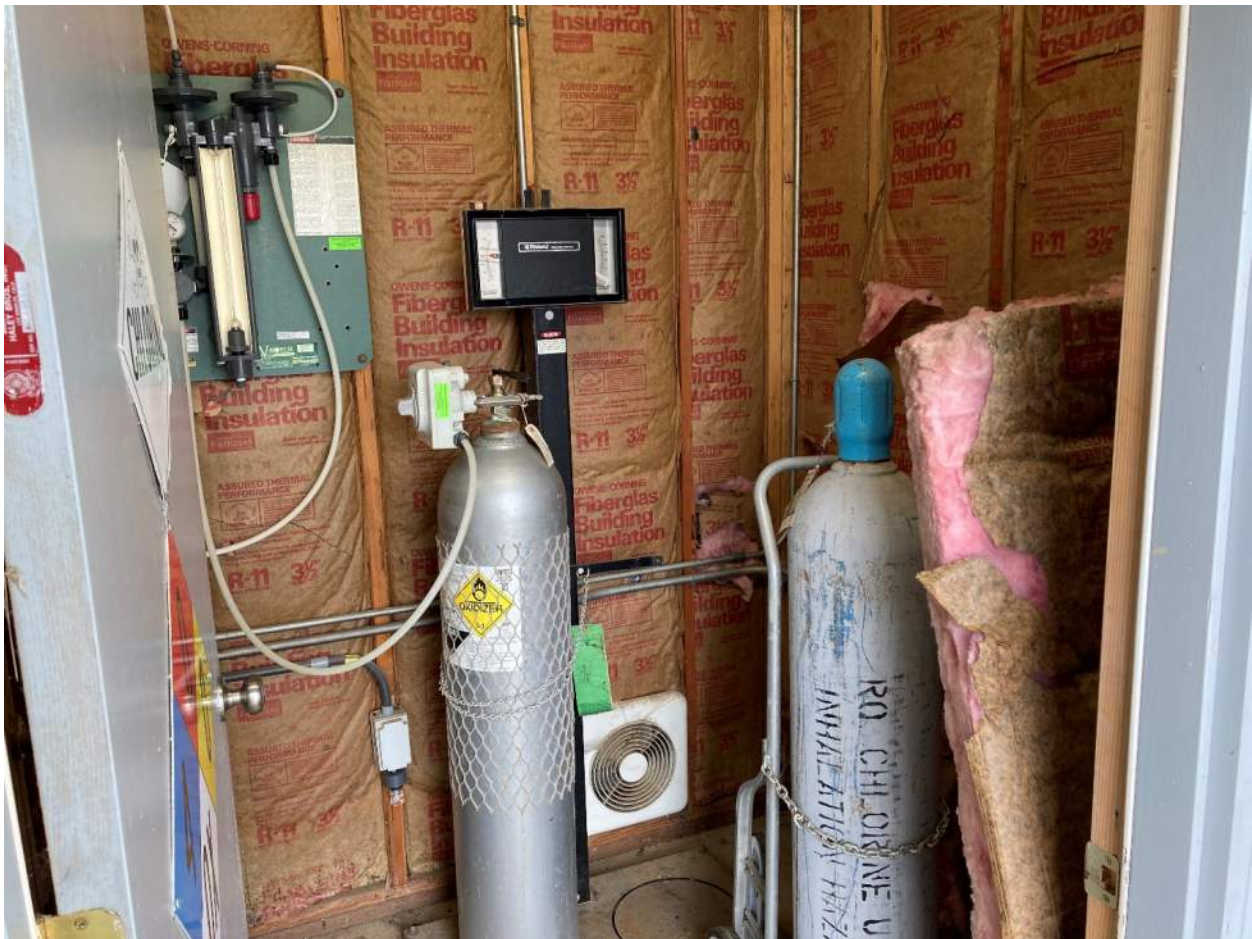
Figure 2-6 Gas Chlorination System

Observations: At the time of the visit, the treatment plant was not discharging to the creek and the chlorination and dechlorination systems were not in use, however both systems appear to be in good working condition. During the inspection of facilities, a manhole with equipment and piping was observed near the end of the chlorine contact chamber, adjacent to the discharge manhole. It was unclear what the purpose of this equipment was, or how it functions with respect to the operation of the plant. It appeared to be a tablet type dechlorination system that is no longer in use, no records were found to explain its function or if it is associated with the current dechlorination system.

Recommendations: Due to safety concerns with the storage and use of chlorine gas, it is recommended that the chlorination system be converted to a liquid sodium hypochlorite system. A sodium hypochlorite system would be similar to the current dechlorination system, with chemical metering pump pulling from drums or totes. It is recommended the system be provided with two metering pumps for redundancy, containment and piping for calibration.

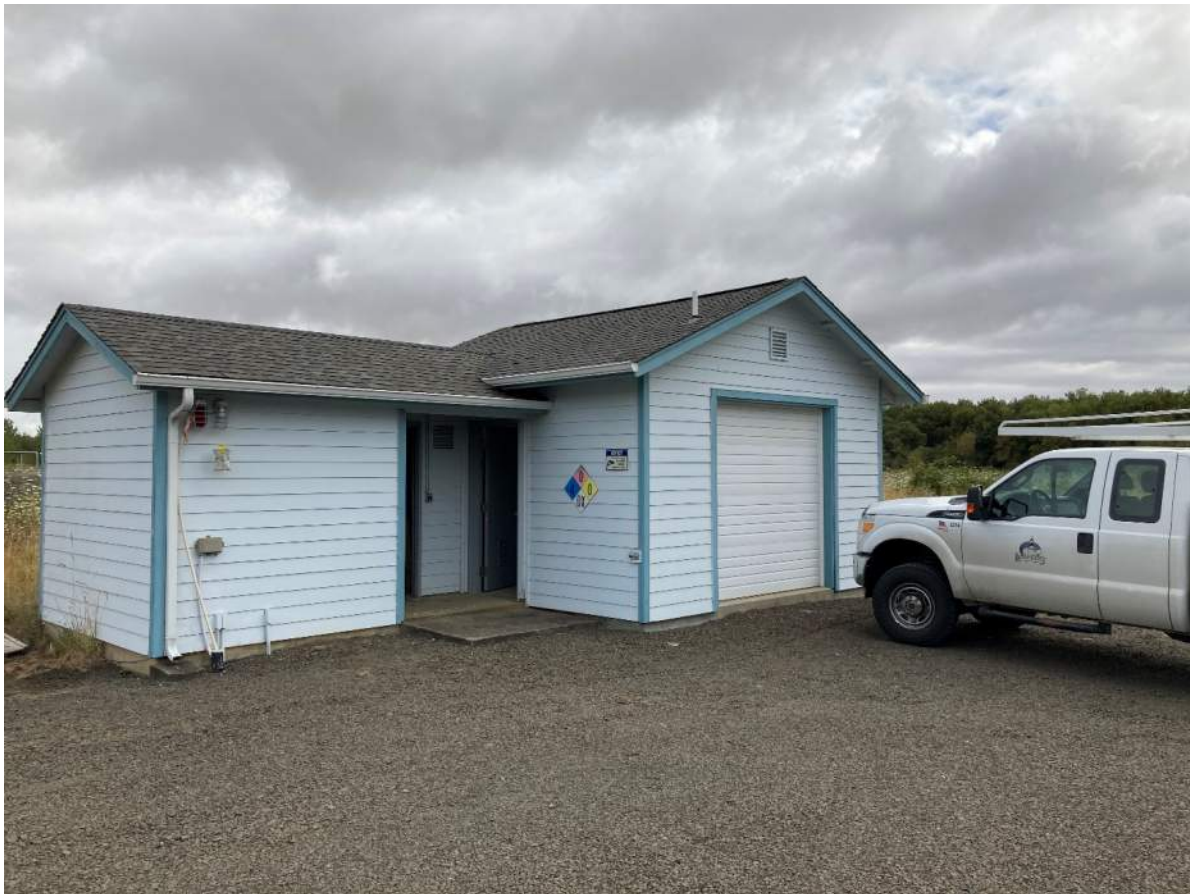
Figure 2-8 Support Building

Observations: The structure appears to be in good condition. The room housing the electrical and controls equipment is small and space is limited to desk/work bench area, as well as storage of records and manuals. The process building does not currently have any eye wash stations but the County is currently in the process of ordering equipment for all facilities where applicable. There are no restroom facilities on site.

Recommendations: With implementation of the recommendation to convert the gas chlorination system to liquid sodium hypochlorite, the new system should be located adjacent to the dechlorination equipment, in the garage area. This will free up space in the building and consideration should be given to expand the electrical and controls room to provide more desk/workspace and storage. Consider the need for a work bench in the garage area to run simple tests and conduct minor equipment repairs or servicing. Consider the need for a restroom at the site.

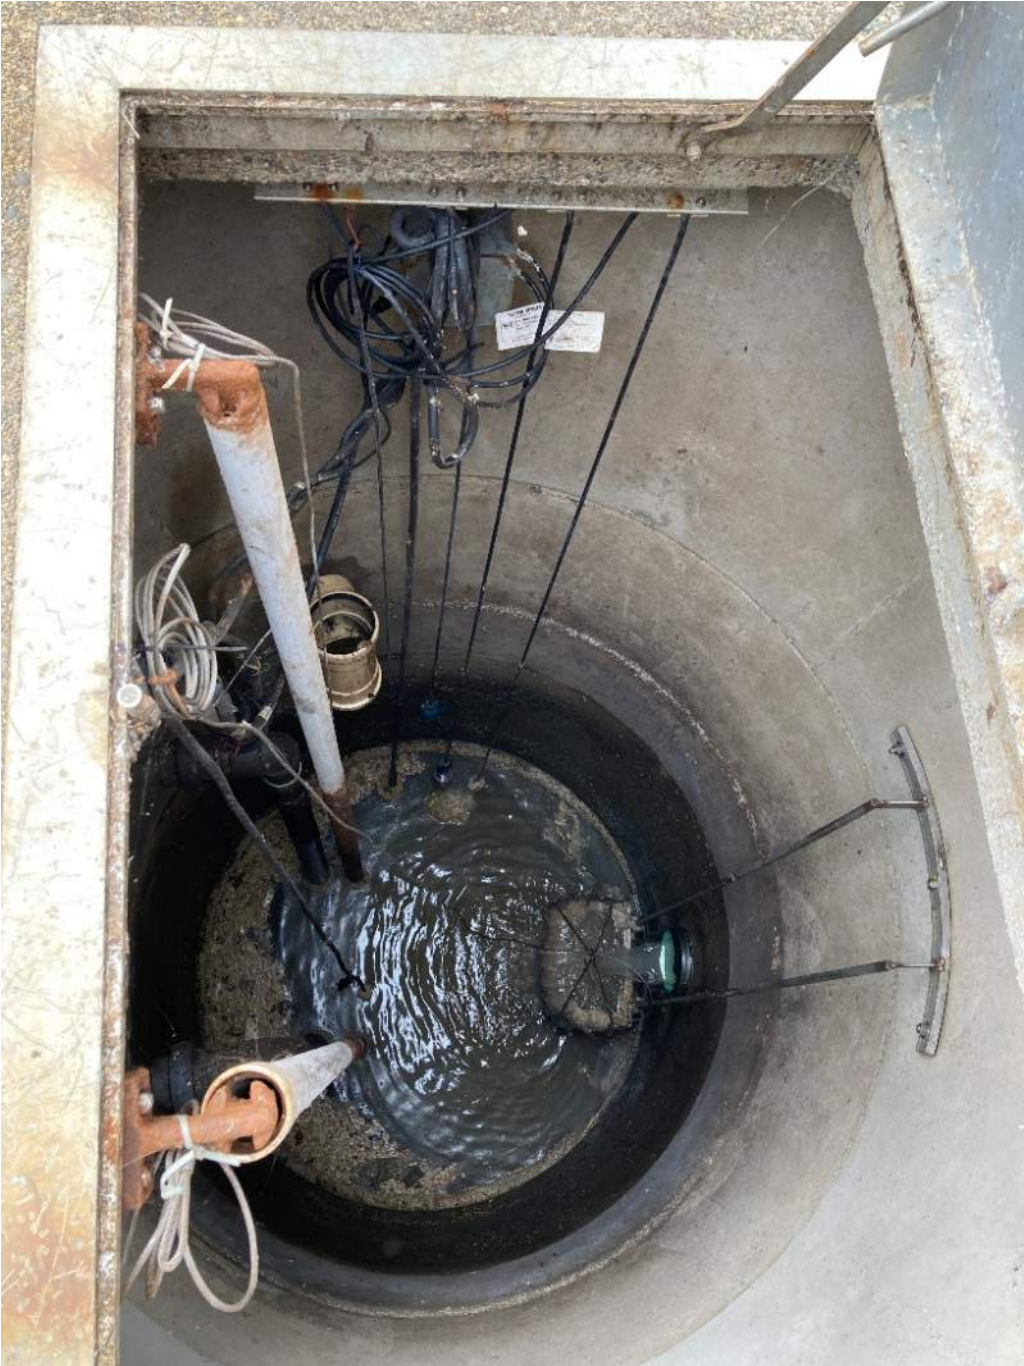
Figure 3-2 Influent Lift Station

Observations: The concrete wet well structure and access hatch appeared to be in good condition. Minor corrosion was observed on the pump's guide rails. Debris was observed in the screening basket and floating in the wet well, the type or accumulation of debris did not seem unusual for a wastewater pump station. The electrical equipment and controls appear to be operable; the electrical equipment appears to be lacking adequate clearance in the space per code. The wooden structure needs to be painted and does not provide any security for the electrical equipment and controls.

Recommendations: Continue to pursue replacement of the pumps with the Flygt pumps. With the new pumps, the need for the screening basket should be eliminated and it should be removed from the wet well. The Flygt pumps should be able to pass the debris through to the septic tanks where it will be captured and disposed of with the solids.

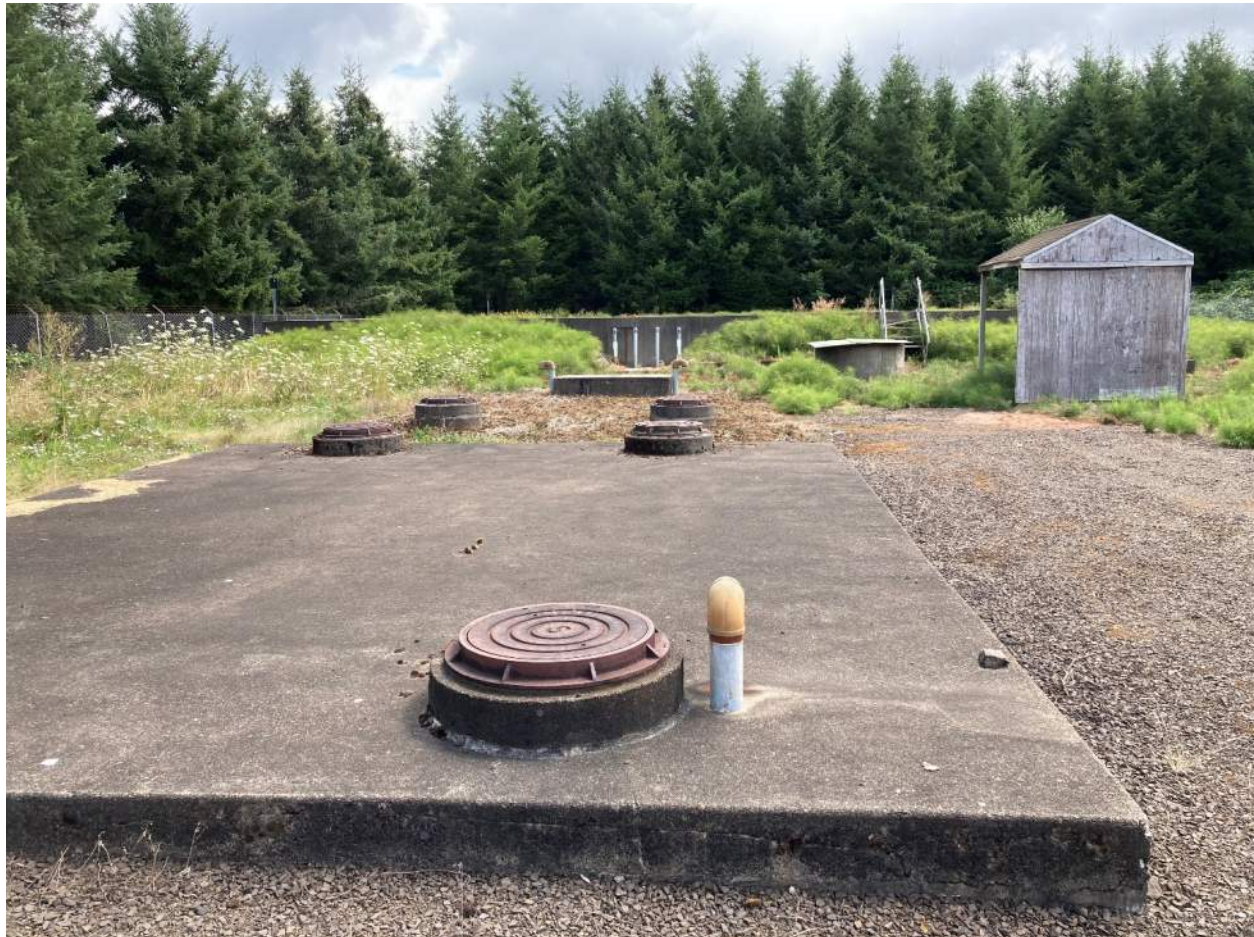
Figure 3-4 Septic Tank in Foreground, Wooden Structure Housing Controls

Observations: The interior of the concrete tanks and below grade structures were not observed since they were in service. From the exterior and at access manways, the tanks and structures appeared to be in good condition, with typical wear of concrete. PVC pipes entering the filter

Recommendations: During the next septic tank pumping cycle, clean and conduct a video inspection of all the tanks to document the condition of the interior. Replace PVC pipes and valves entering the filter structure with piping that is ultraviolet (UV) resistant or provide a cover for the exposed piping. Replace the stairway at the filter structure and provide a secure cover for the splitter box. Remove vegetation on top of the filter and around all tanks and structures.

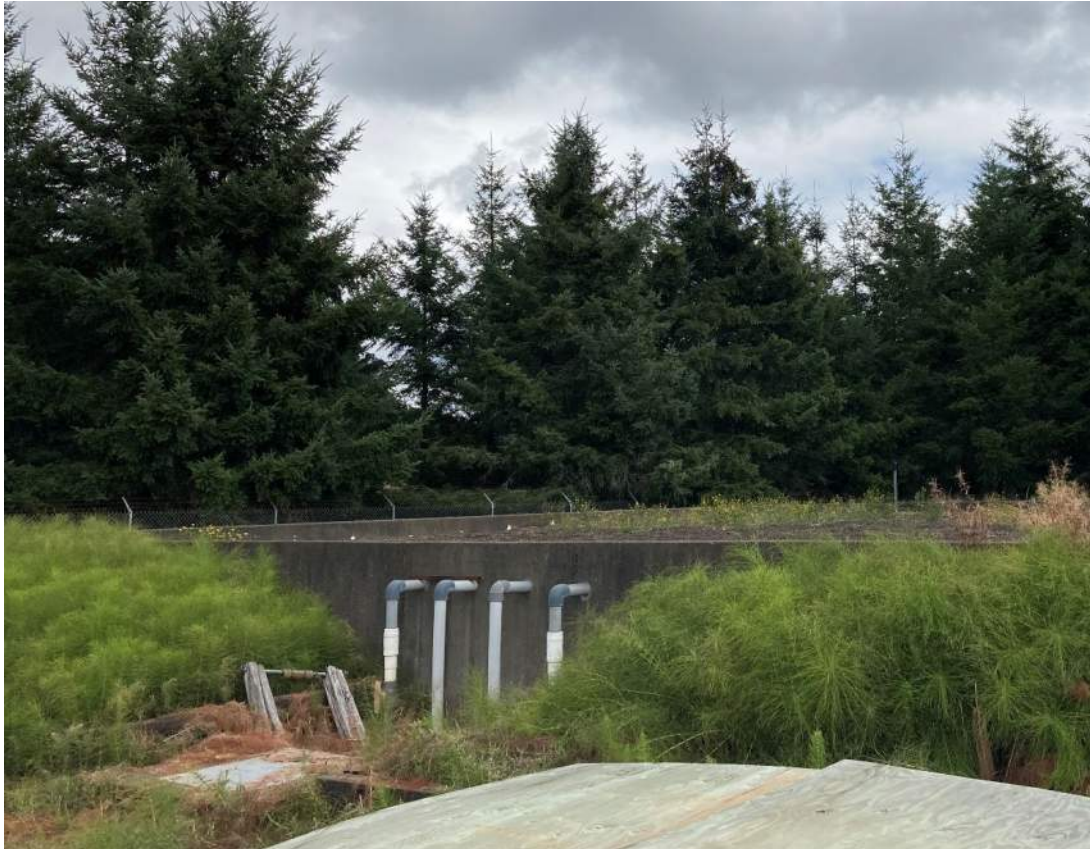
structure are exposed. The stairway leading up to the gravel filter is dilapidated and no longer usable. The cover on the splitter box is plywood and not secure.

Distribution and underdrain piping in the filter basin could not be observed. There is some vegetation on top of the filter. Heavy vegetation surrounds the filter structure.

Figure 3-5 Recirculating Gravel Filter Basin with PVC Piping, Wooden Cover to Splitter Box in Foreground

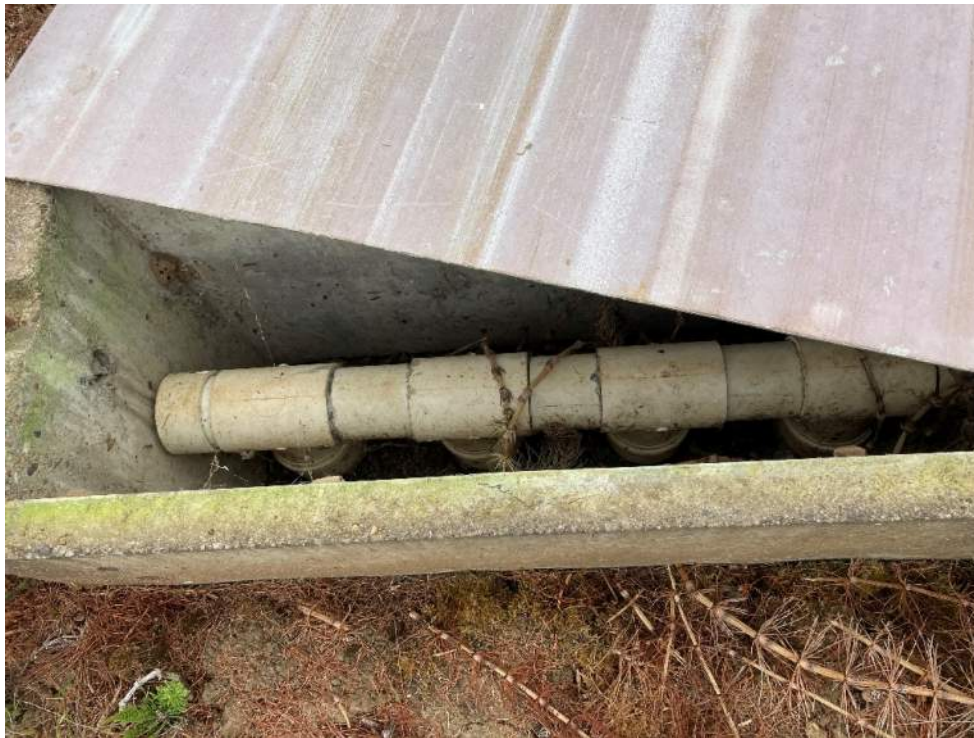
Figure 3-6 Distribution Box with Lid

Observations: The drain field tank and distribution boxes are in good condition, showing typical wear of the concrete and hatches. The interior of the drain field tank was not observed since it was in service. The lids on the distribution boxes were not secure.

Recommendations: As part of the next septic tank pumping cycle, clean and conduct a video inspection of the drain field tank. Secure the lids on the distribution boxes. Install monitoring ports in the drain fields to monitor performance.

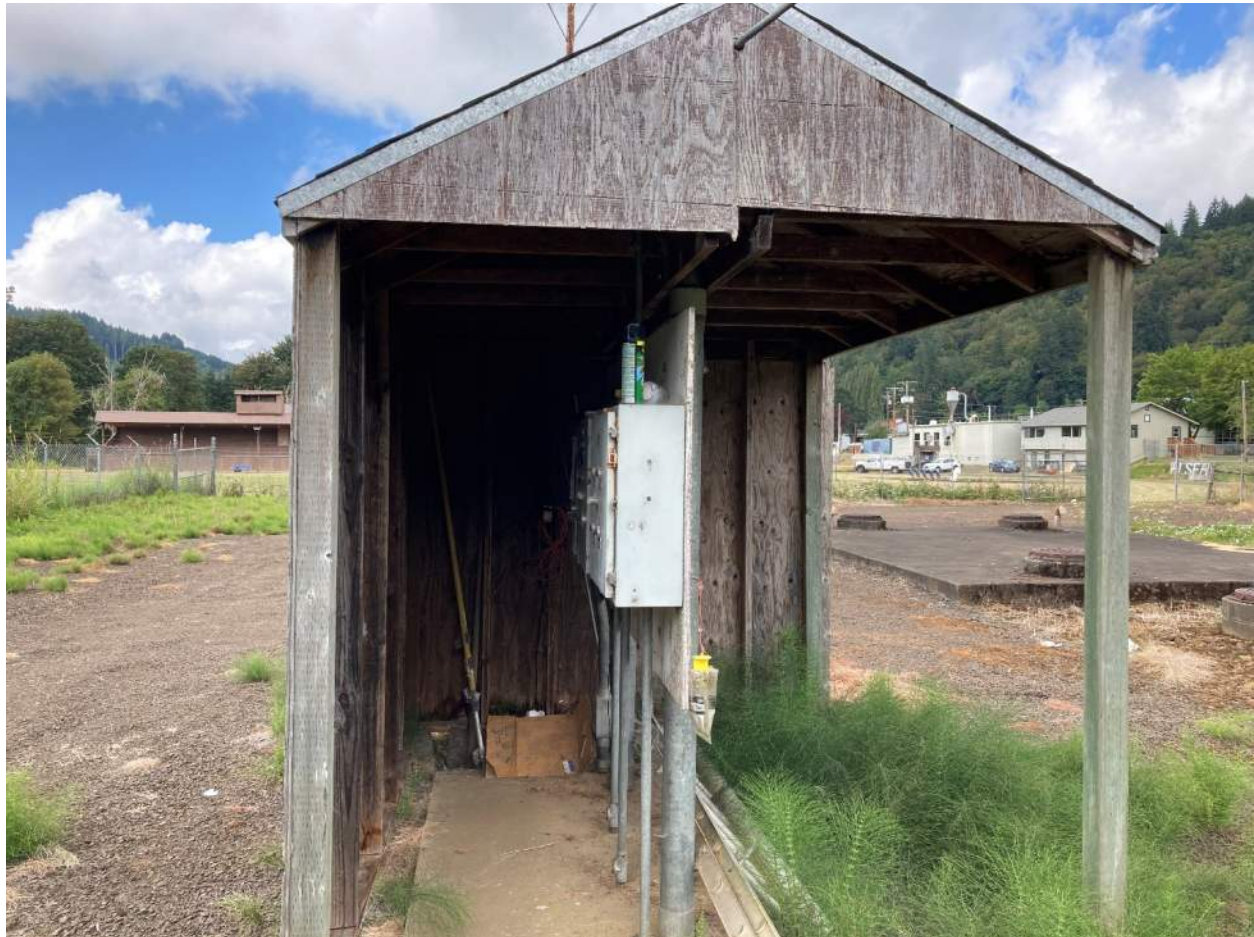
Figure 3-7 Electrical Equipment and Controls Structure

Observations: The electrical equipment and controls appear to be operable; the electrical panels are showing some corrosion on the exterior and there appears to be inadequate clearance in the space per code. The wooden structure needs to be painted.

Recommendations: Provide an enclosed, secured building or structure for the electrical equipment and controls with adequate clearance complying with current codes. Provide additional space to accommodate operation and maintenance activities at the site, such as a work bench/desk and storage for records and documents.

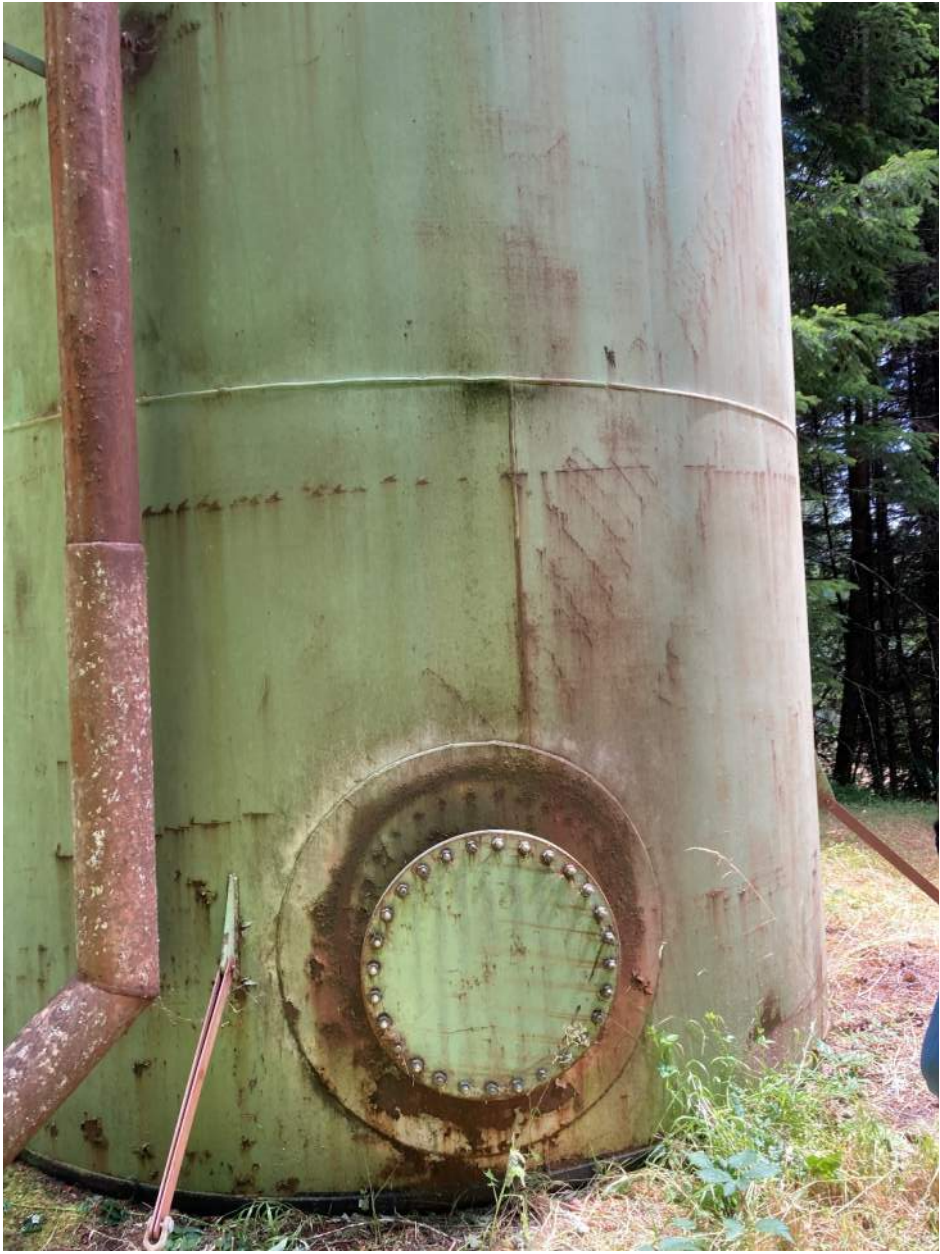
Figure 4-5 Access Hatch and Pitting on Welded Steel Storage Tank

Both tanks should be cleaned, interior and exterior. A formal tank inspection program should be performed including seismic analysis of both tanks. Any consequent recommendations for repair or seismic mitigation should be performed.

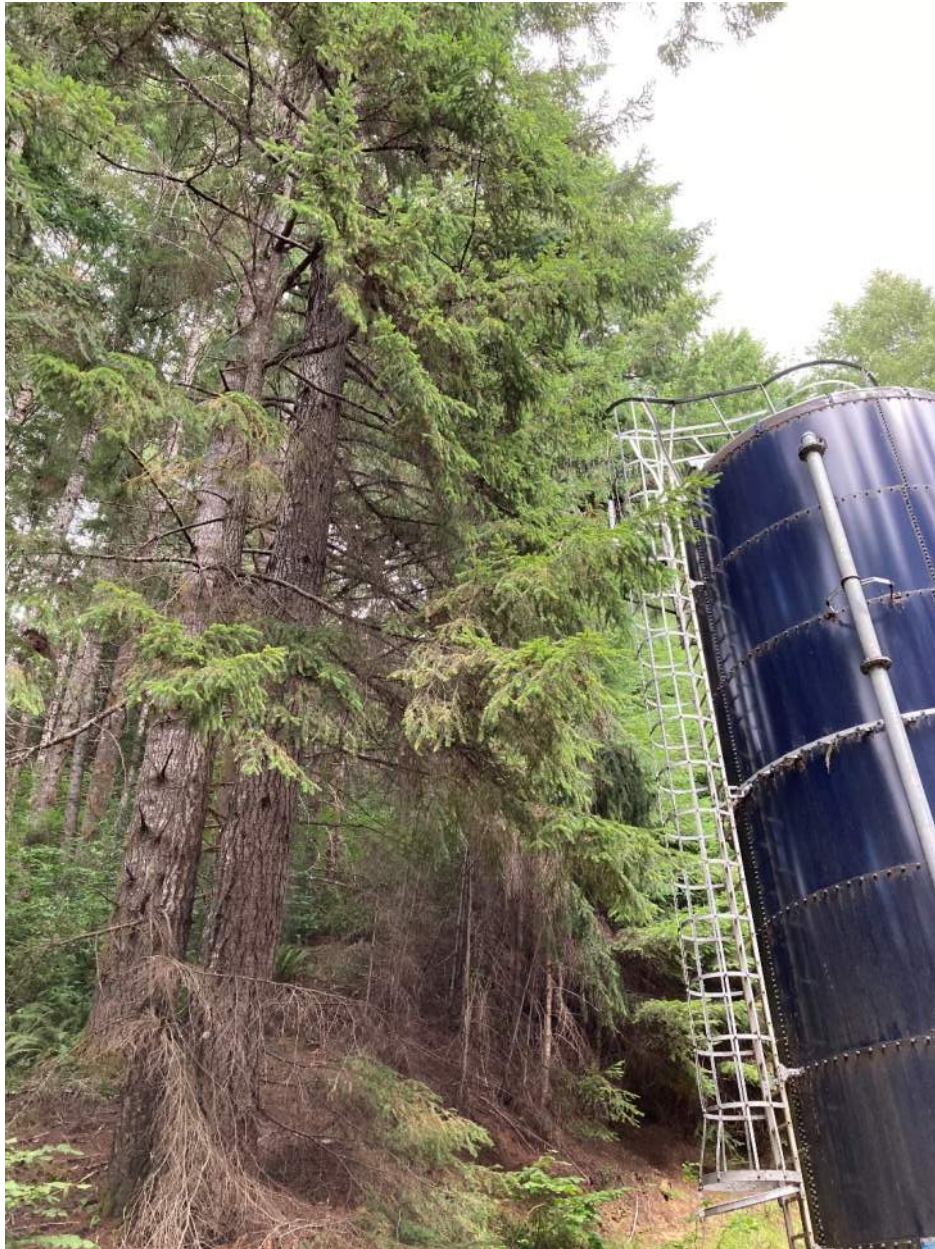
Figure 4-6 Vegetation Overhanging Bolted Steel Storage Tank

Recommendations: A professional arborist should be hired to remove branches and trees overhanging the tanks or that are in danger of falling onto the tanks.

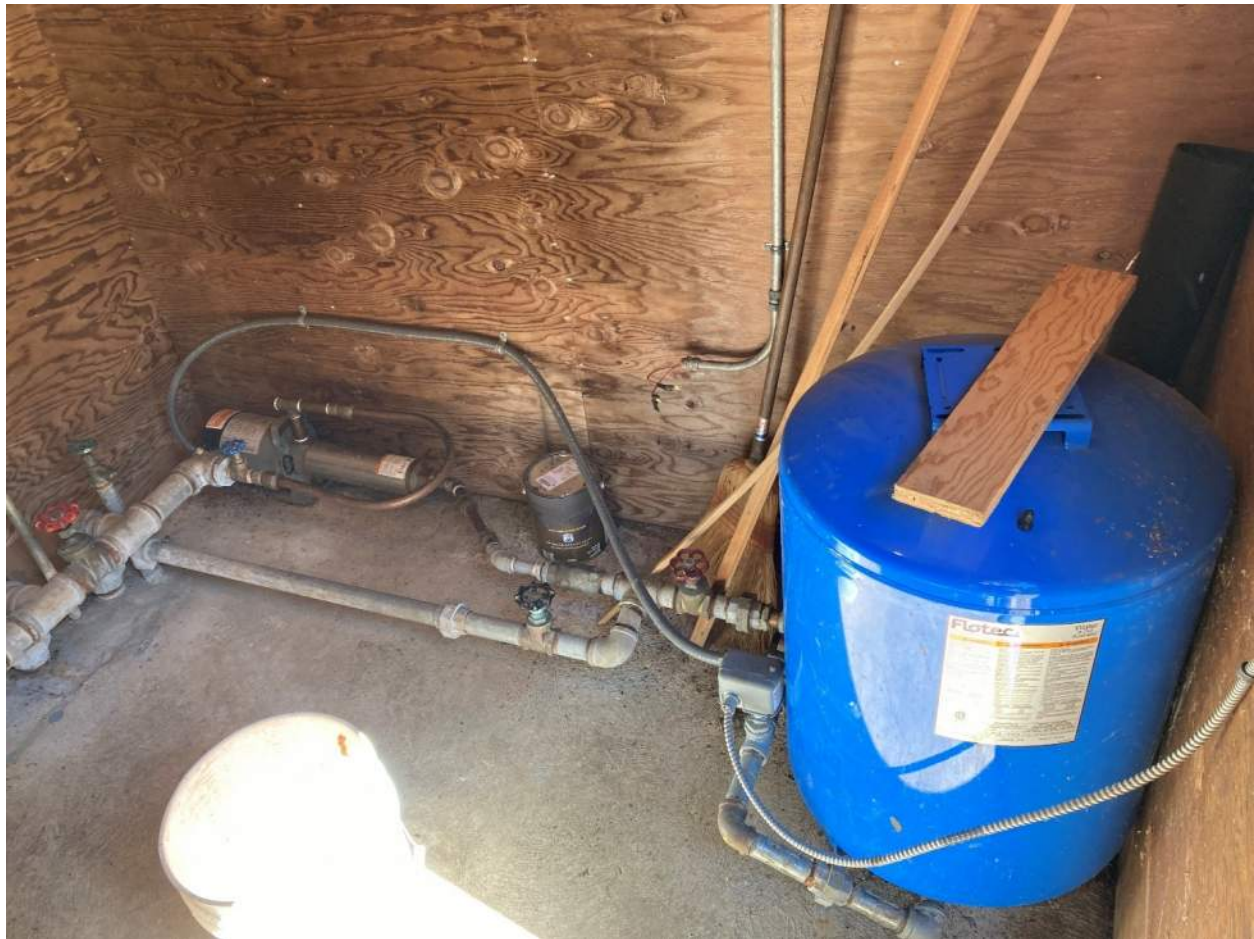
Figure 5-4 Pressure System

Observation: The pump and pressure tank are in good working order.

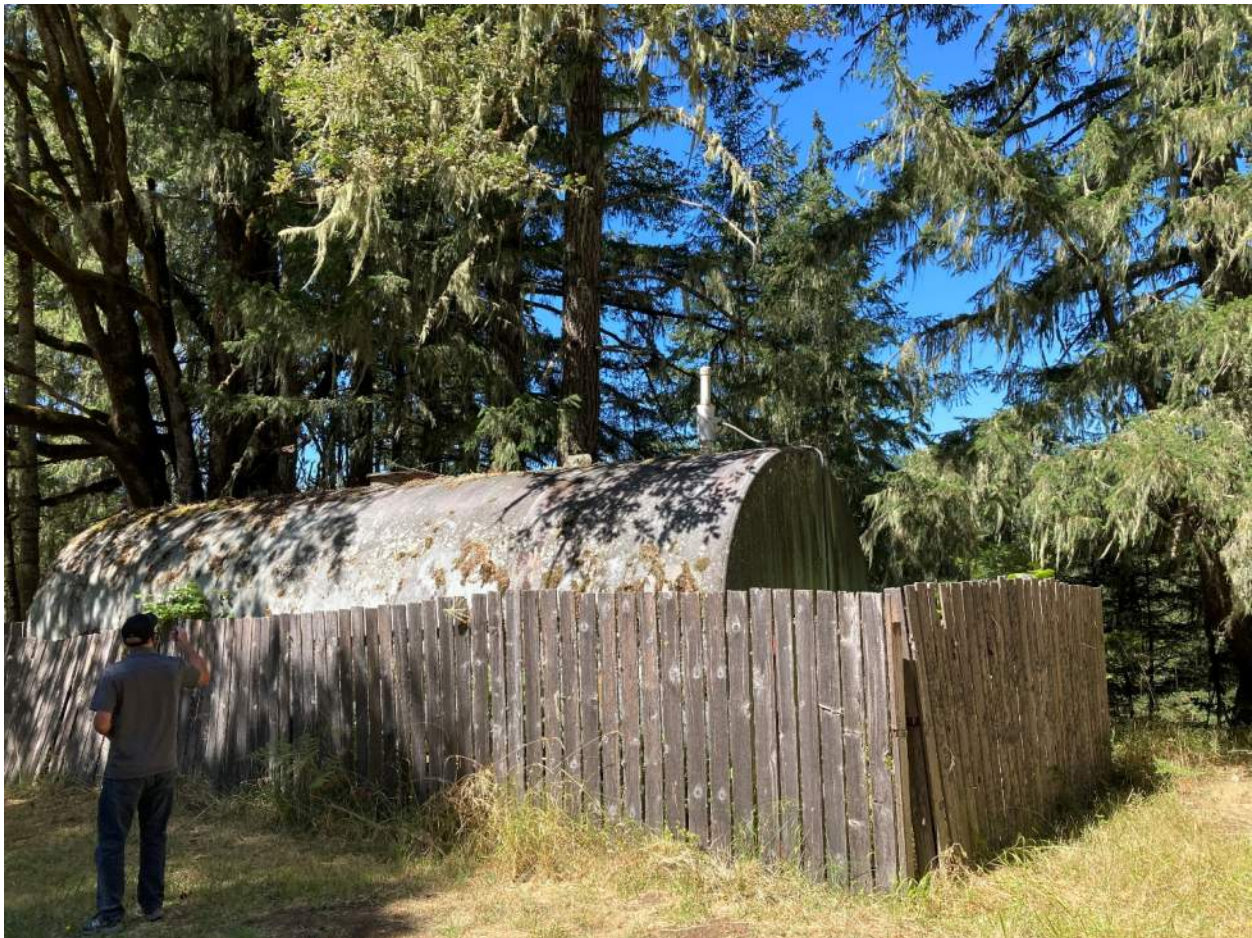
Figure 5-5 Hidden Valley Storage Tank

Observations: The existing coating on the tank has failed in a number of locations. The surrounding trees are encroaching over the tank and appear to be contributing to the debris and moss build-up on the tank and most likely are causing issues with the coating system. The trees could cause a structural issue if trees or limbs were damaged during a storm event. The fence around the tank is in poor condition and vegetation is growing against the tank.

Recommendations: A formal tank inspection should be undertaken to assess the structural integrity of the tank and determine its remaining service life. If it is determined that there is remaining service life, the tank's interior and exterior should be painted. If the service life is limited, less than 20 years, replacement of the tank should be considered.

The surrounding trees should be limbed by a professional arborist to protect the tank and its coating system. New gravel surfacing should be placed around and under the storage tank to prevent vegetation growth, and the fence should be replaced.

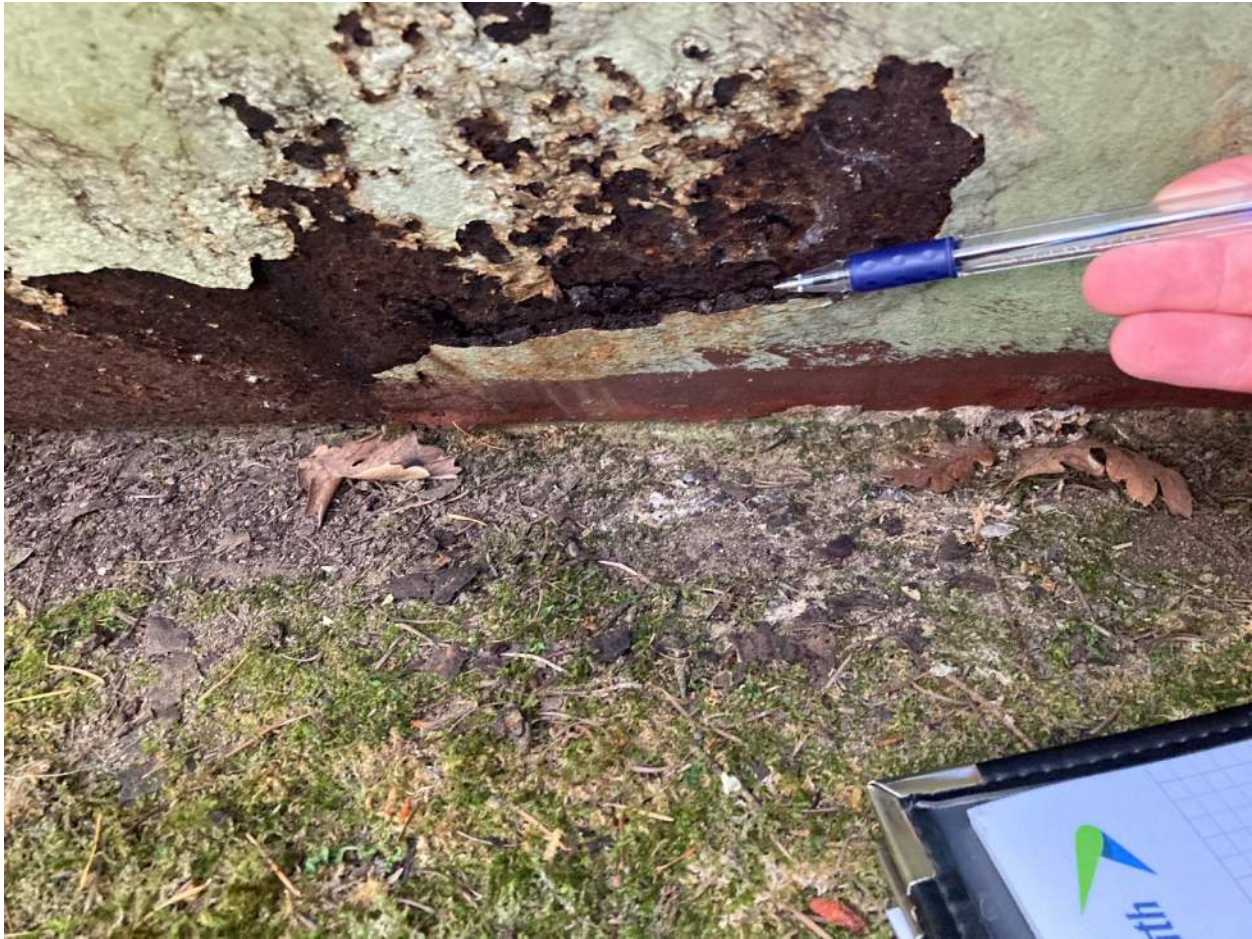
Figure 5-7 Storage Coating Failure

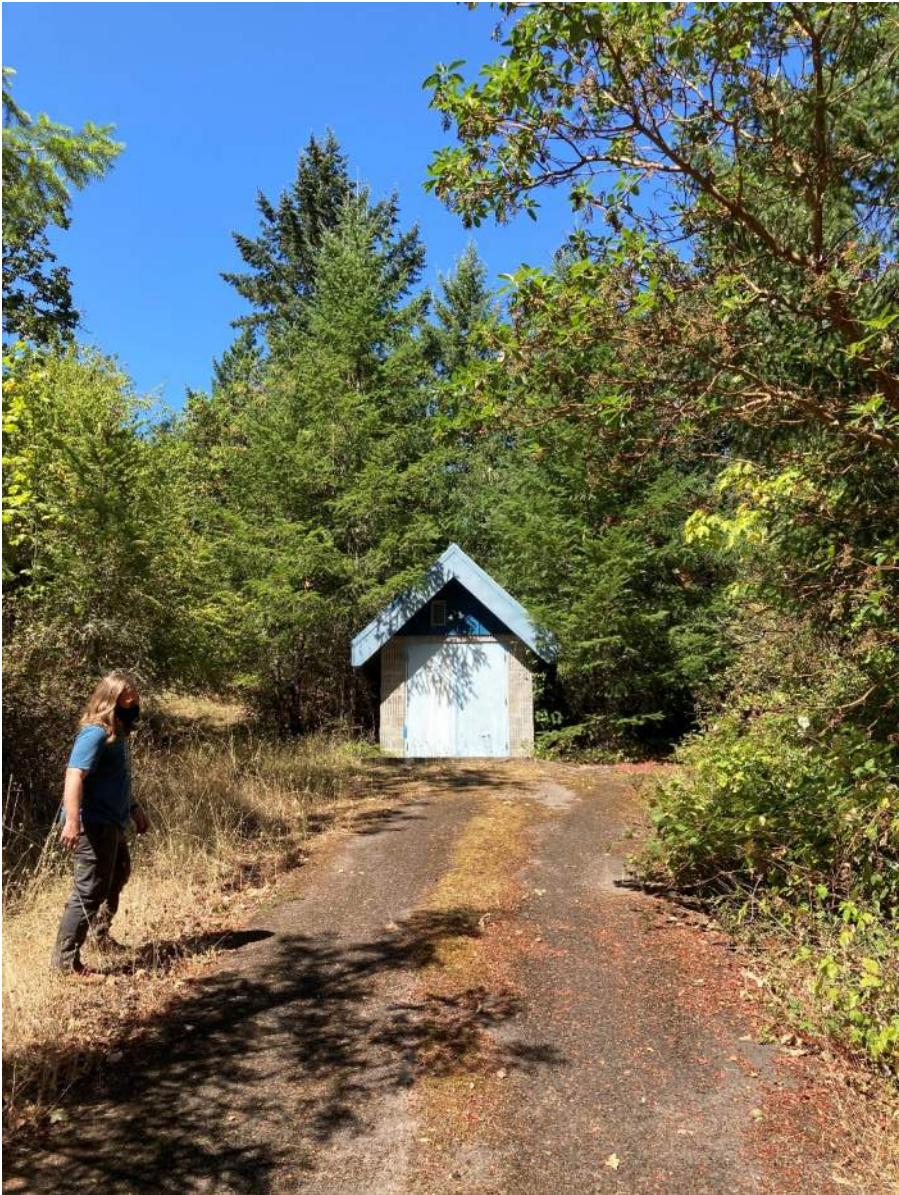
Figure 6-2 Well 1 Well House Exterior

Observation: All the well houses are in good condition due to their relatively recent construction. Well house 1 has trees and vegetation encroaching up the structure.

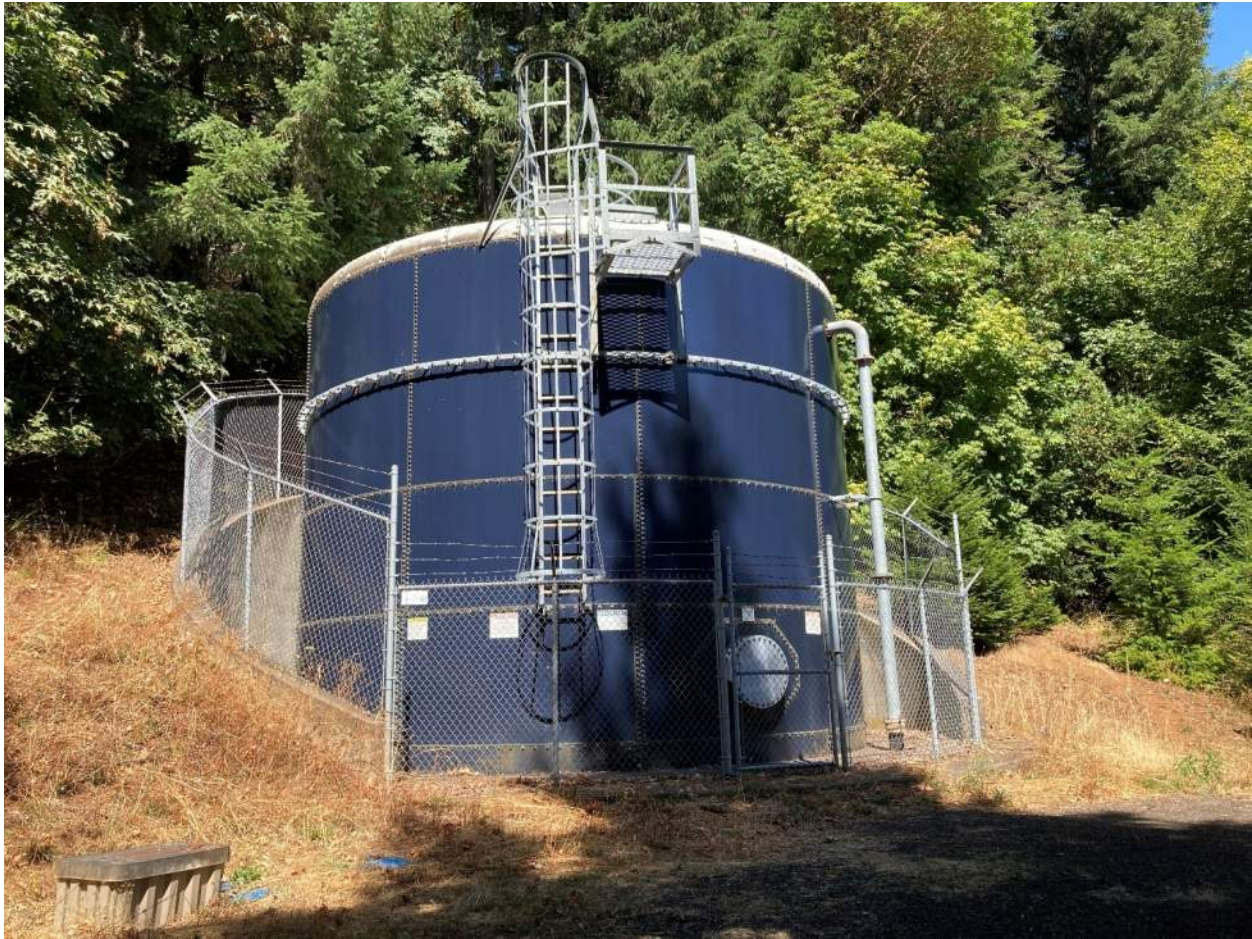
Figure 6-7 Cascade View Storage Tank

A single 71,000 gallon storage reservoir feeds the distribution system. The tank is a glass lined, bolted steeltank sitting at an elevation approximately 375 ft above the main supply well. The tank was recently inspected by a dive team and is in good condition.

The tank's overflow should be located and investigated to make sure there is no blockage, and the outfall has adequate screening.
