BENTON COUNTY
Utility Assessment
November 2021

Utility Assessment

Benton County, Oregon

November 2021

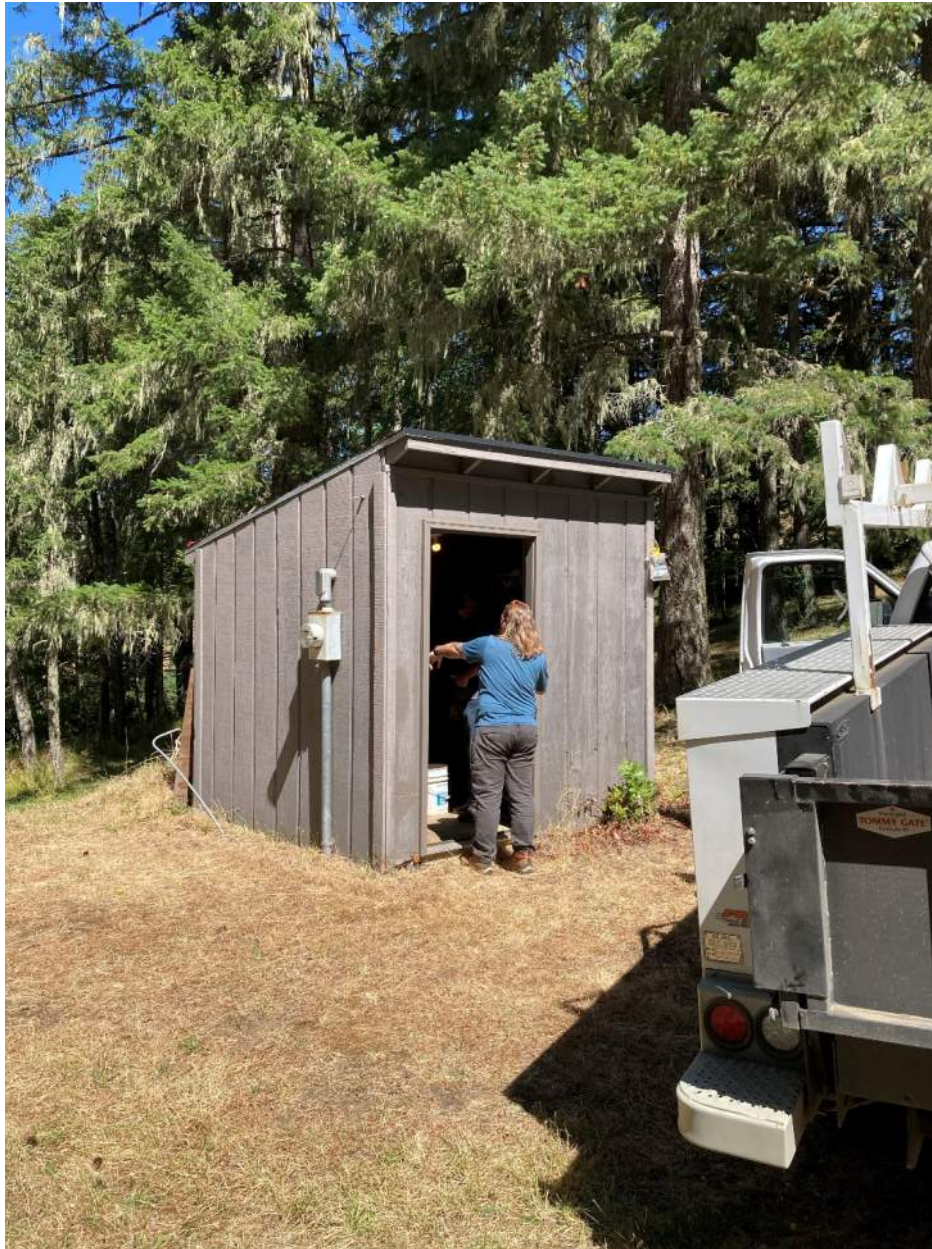
Figure 5-2 Hidden Valley Wellhouse

Recommendations: Keep spare pump and/or parts in stock in case of a pump or system failure.

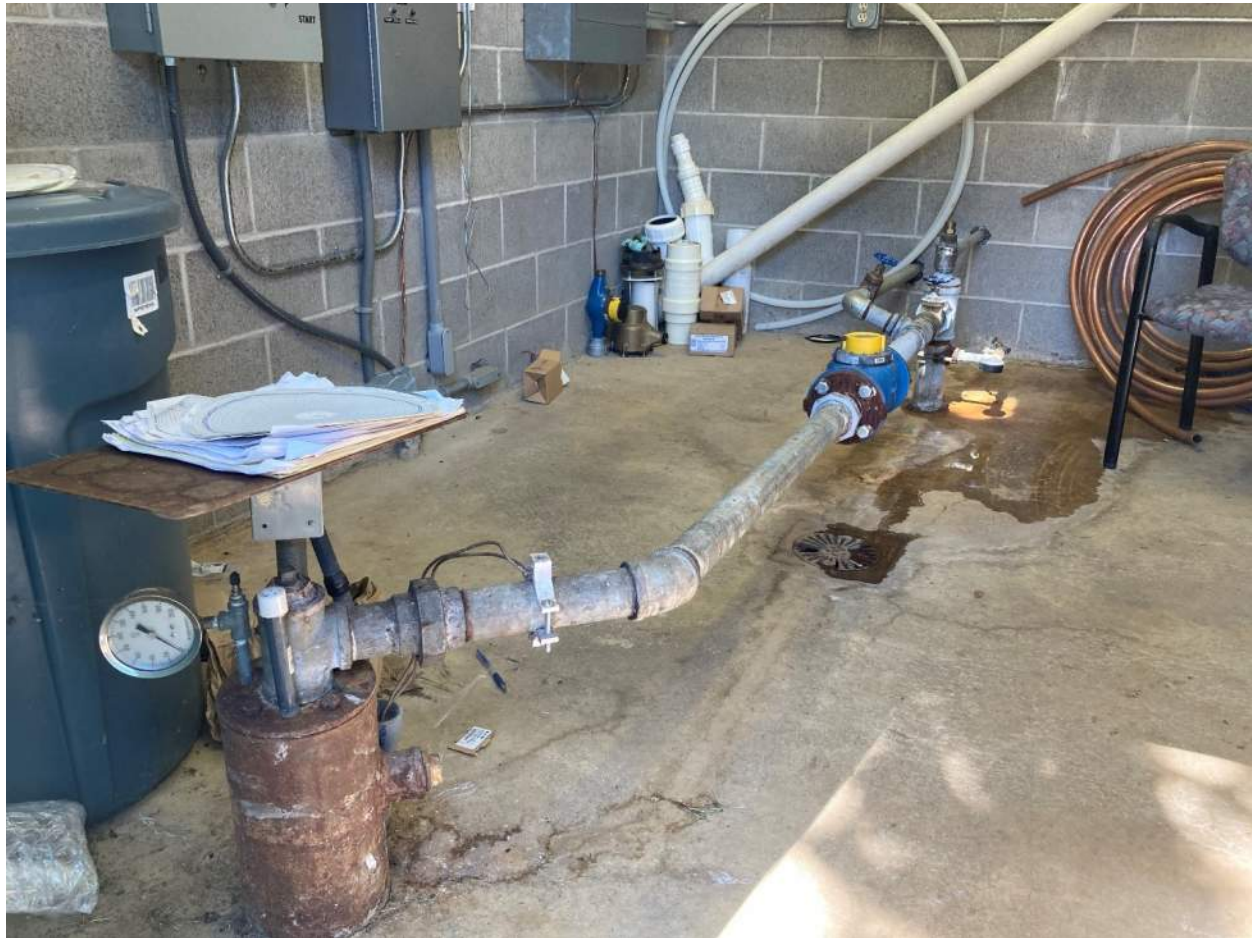
Figure 6-3 Well 2 Wellhead and Flowmeter

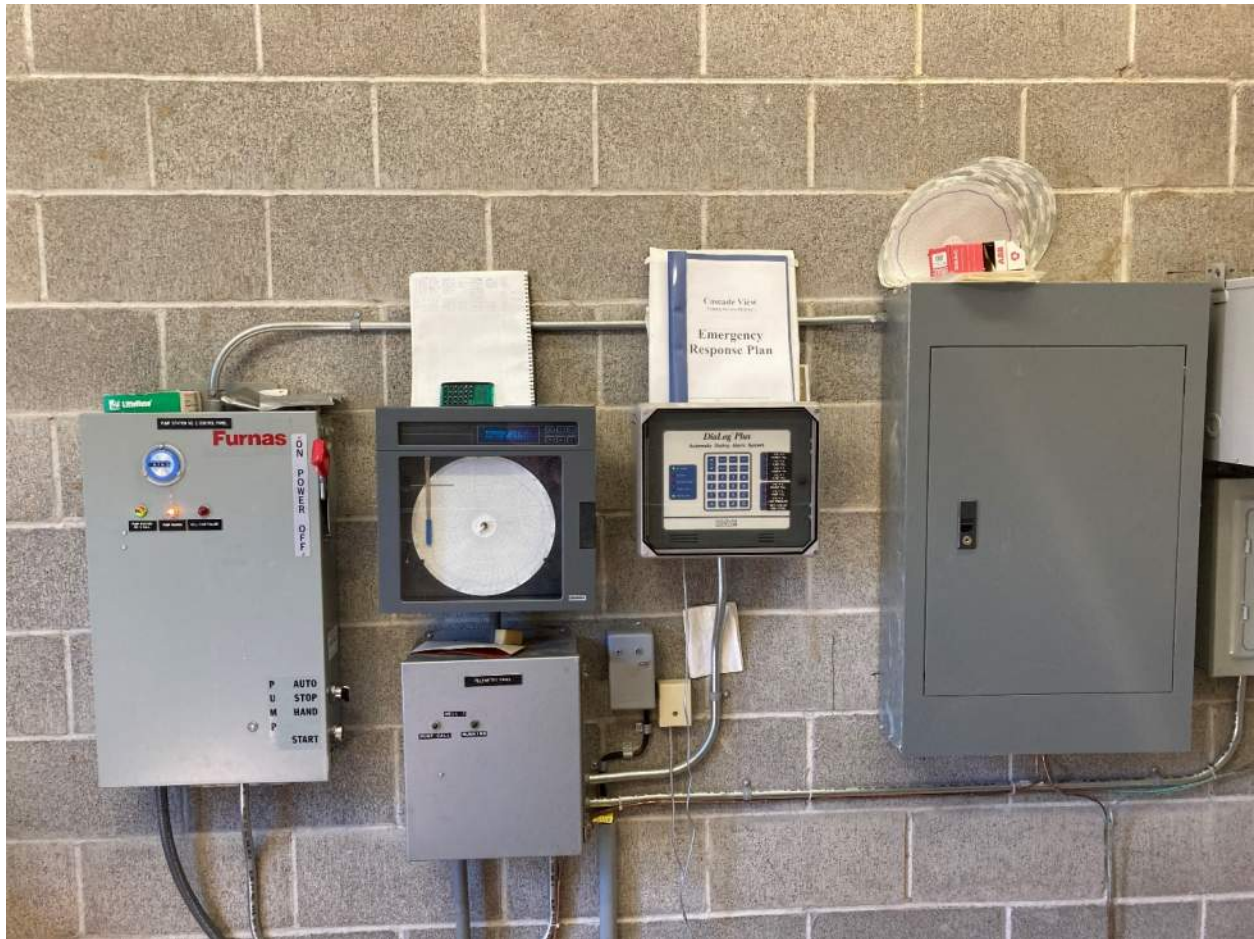
Observation: Control equipment and power provisions appear to be in good working condition at the site.

Figure 6-4 Well 2 Controls and Electrical Equipment

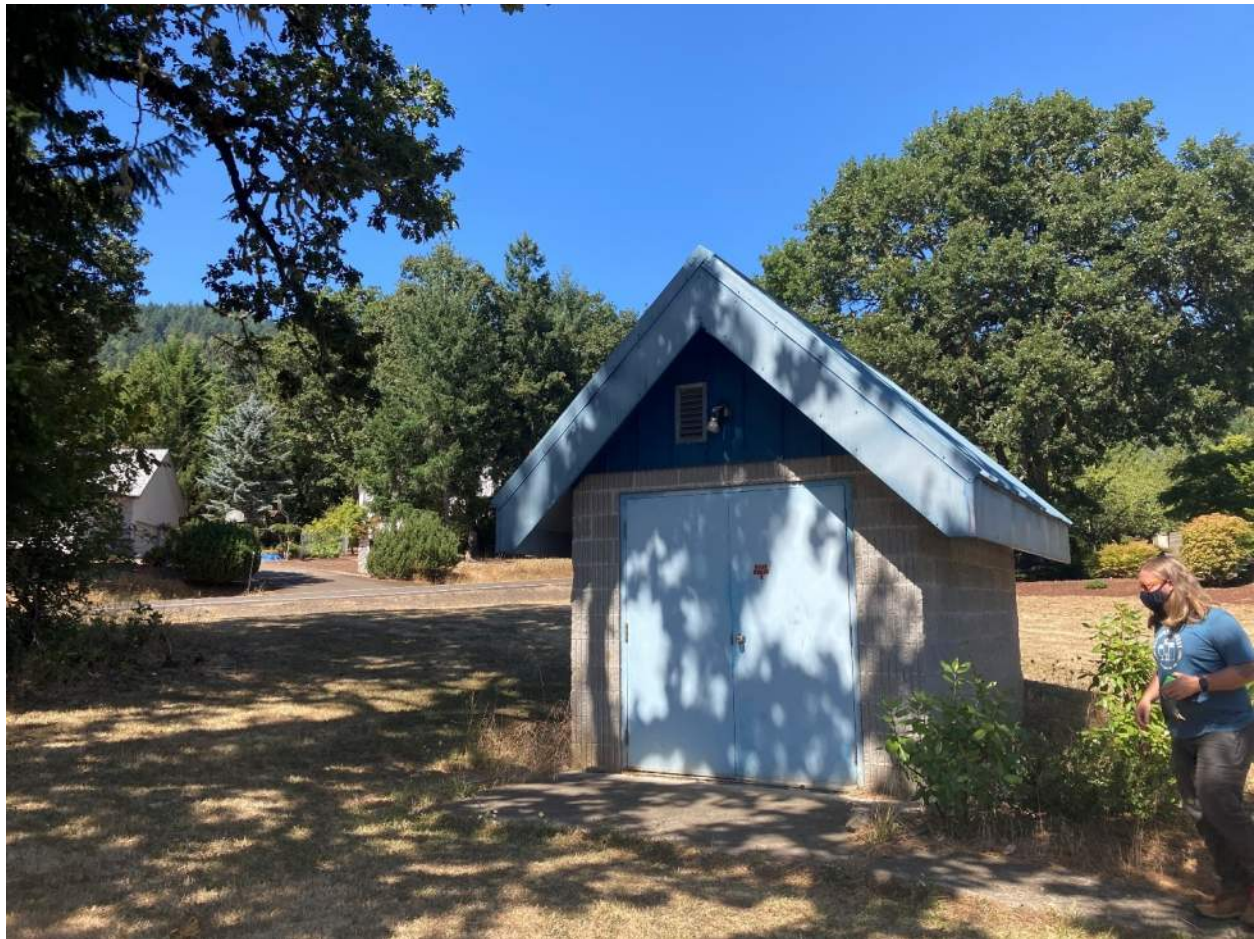
Observations: Well 2 is located in a high traffic area and is very visible to road traffic. The site does not have any security fencing or other security provisions such as intrusion alarms, cameras or lights.

Figure 6-5 Well 2 Wellhouse

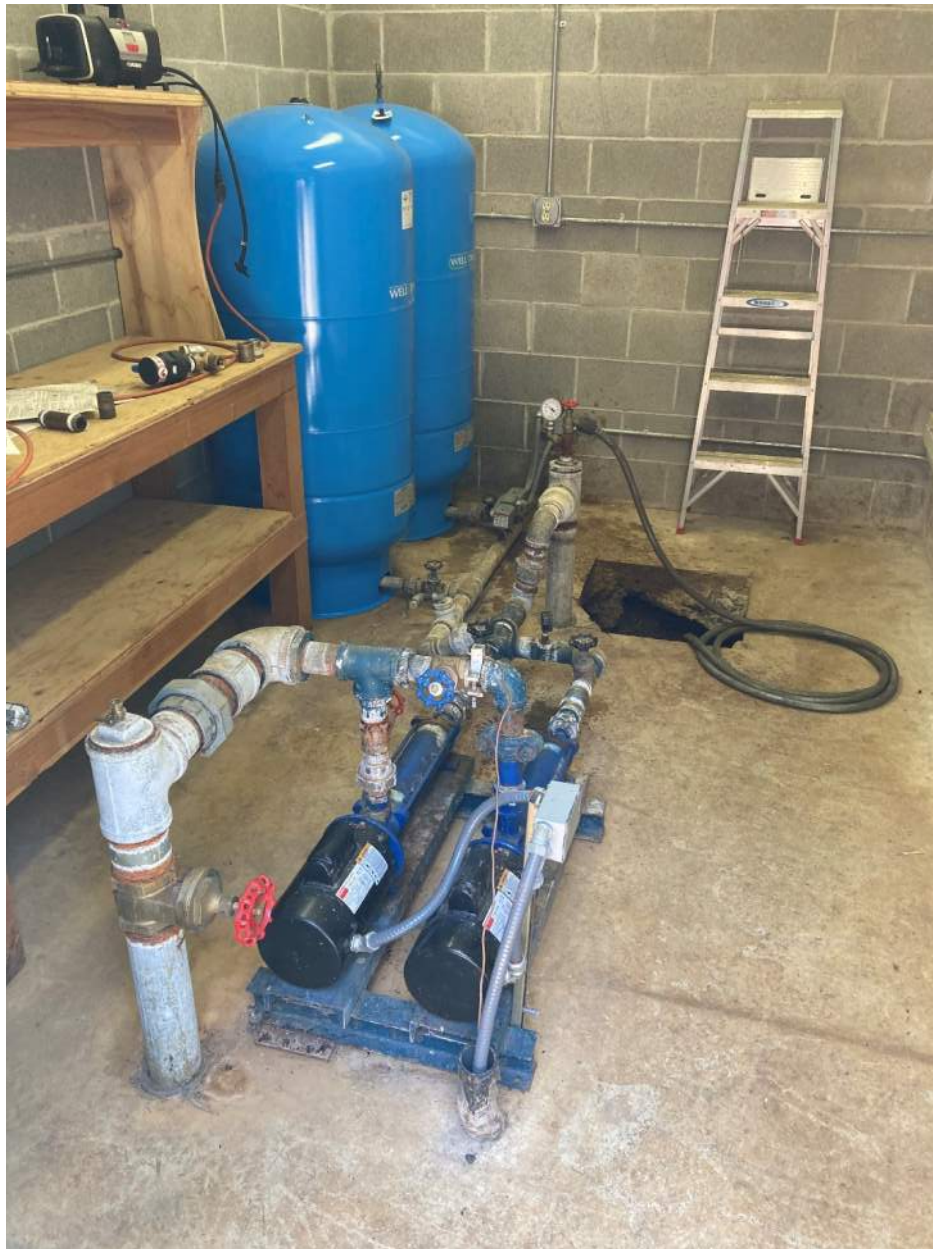
Observations: The pressure system is in good working order and no issues have been experienced recently. There was a sawcut patch in the building floor during the initial observation. The hole in the floor had a small hose connected to the discharge line on the duplex pumps.

Figure 6-6 Pressure System
